## A PHENOMENOLOGICAL INVESTIGATION OF IN-REACTOR CRACKING OF TYPE 304 STAINLESS STEEL CONTROL ROD CLADDING

Wear and hairline cracking have been observed in the cladding of rod cluster control assemblies (RCCAs) in several pressurized water reactors (PWRs). The cracks are typically about 10 cm long, oriented longitudinally, and located in the high-fluence region of the rods. This paper reports our findings concerning the cause and nature of the cracking mechanism. Data from miniature-specimen tensile tests, scanning electron microscopy (SEM) investigations, and corrosion tests on control rod cladding that cracked in-service are reported along with the results of a hot cell investigation of an actual in-service crack. Possible causes of failure and comparisons to literature data are also presented.

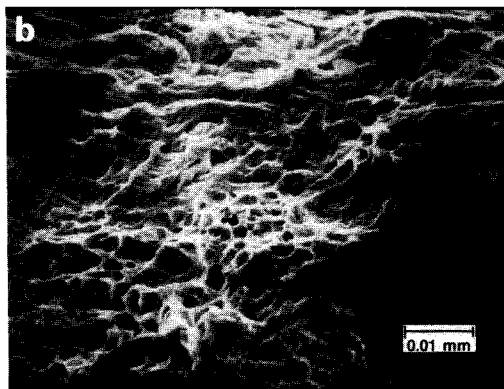
Fig. 1b. SEM micrograph of the fracture surface of specimen C-1 showing a typical ductile fracture surface.

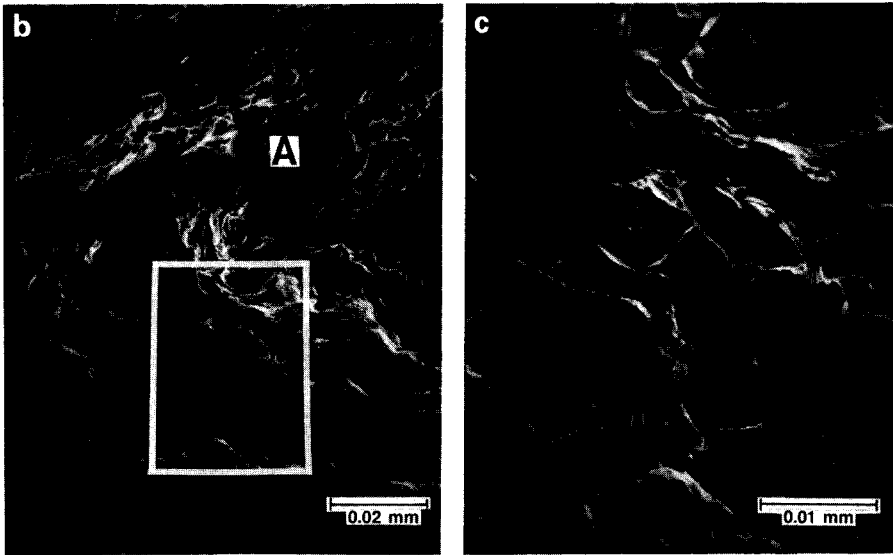
Fig. 2(b). SEM micrograph of region 1-3 of fracture surface of specimen C-2 at higher magnification showing IG fracture. Box enlarged in fig. 2c. (c). SEM micrograph of IG region 1-3 of fracture surface of specimen C-2 at higher magnification showing IG fracture. Box enlarged from fig. 2b.

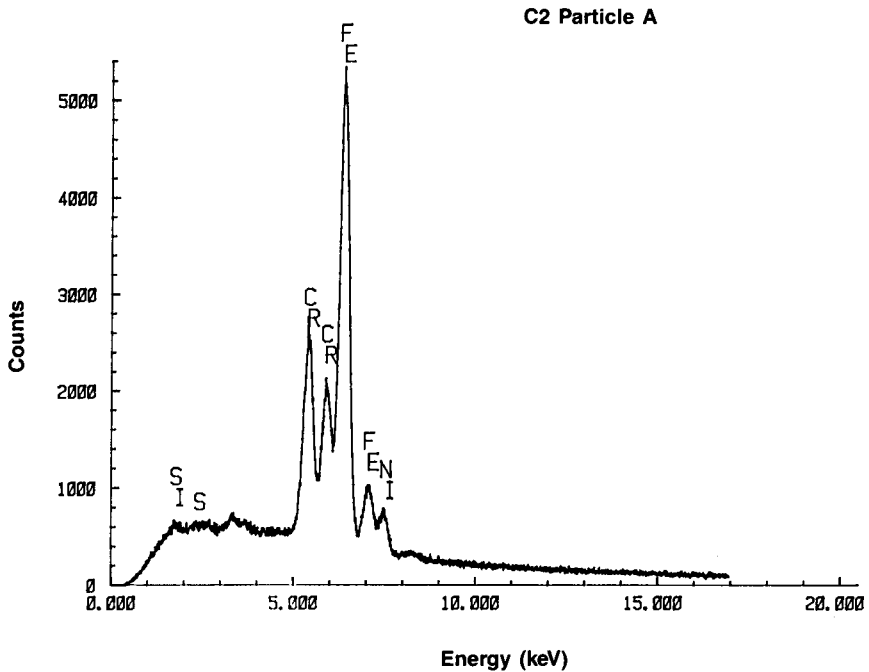
Fig. 2d. EDS analysis of particle A found in specimen C-2.

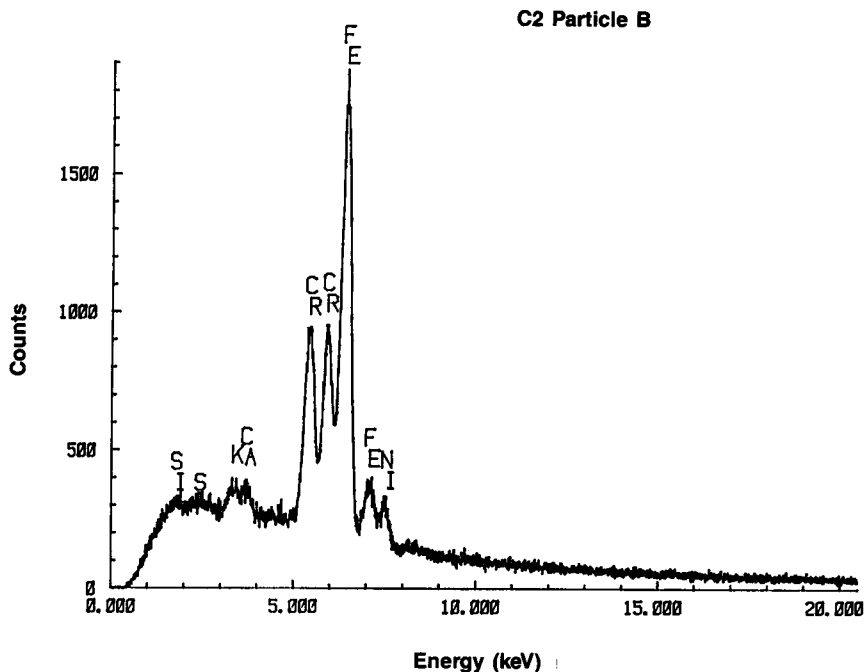
Fig. 2e. EDS analysis of particle B found in specimen C-2.

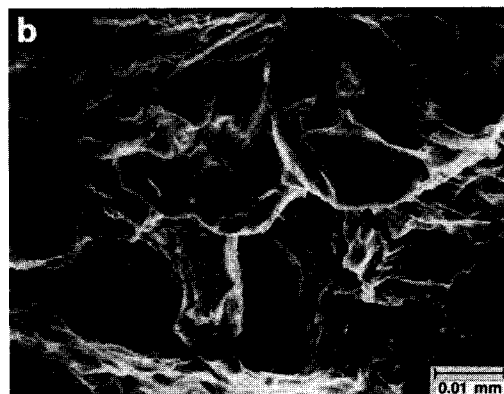
Fig. 3b. SEM micrograph of the IG region 1 of the fracture surface of specimen C-3 at higher magnification.

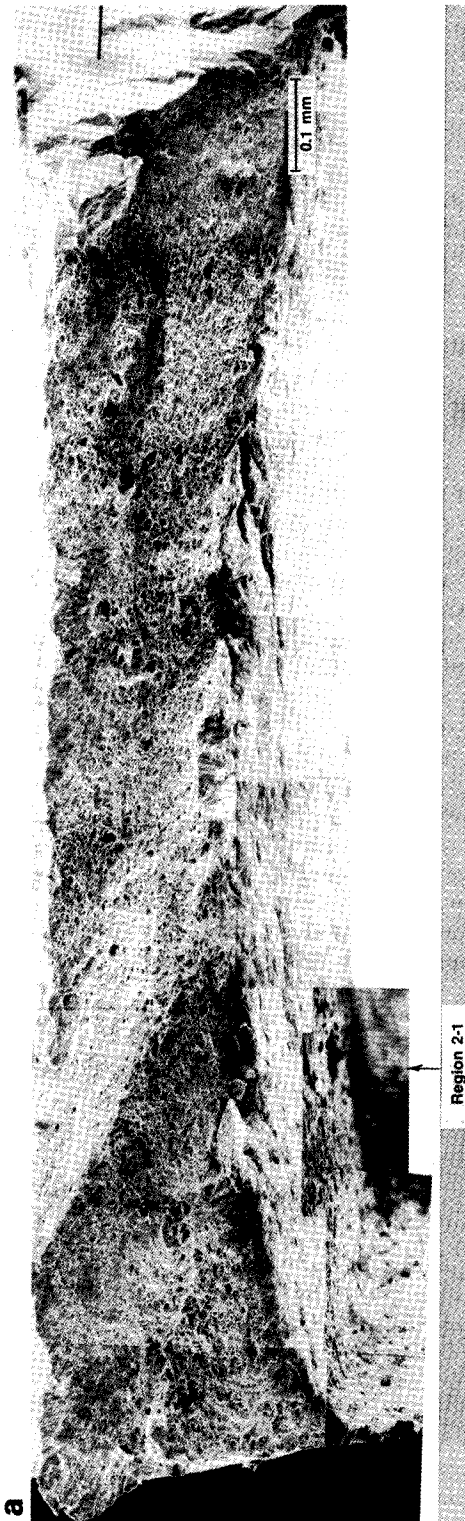
As shown in fig. 4a, for specimen C-4, the bulk of the fracture is ductile in nature, evidenced by the characteristic dimples typical of ductile failure. Approximately 30 to 35% of the fracture is brittle in nature, although clear evidence of IG rupture is lacking, suggesting that other failure modes, such as brittle shear, may also be operating (region 2-1 in fig. 4b). In common with the other specimens, the fracture appears to have initiated near one end of the specimen on the ID.

Fig. 4a. Fracture surface of specimen C-4.

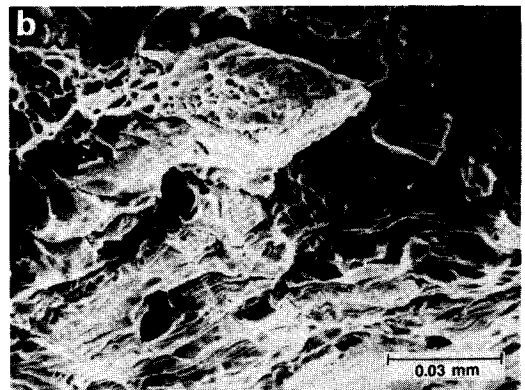
Fig. 4b. Region 2-1 of the fracture surface of specimen C-4 at higher magnification showing IG failure mode.

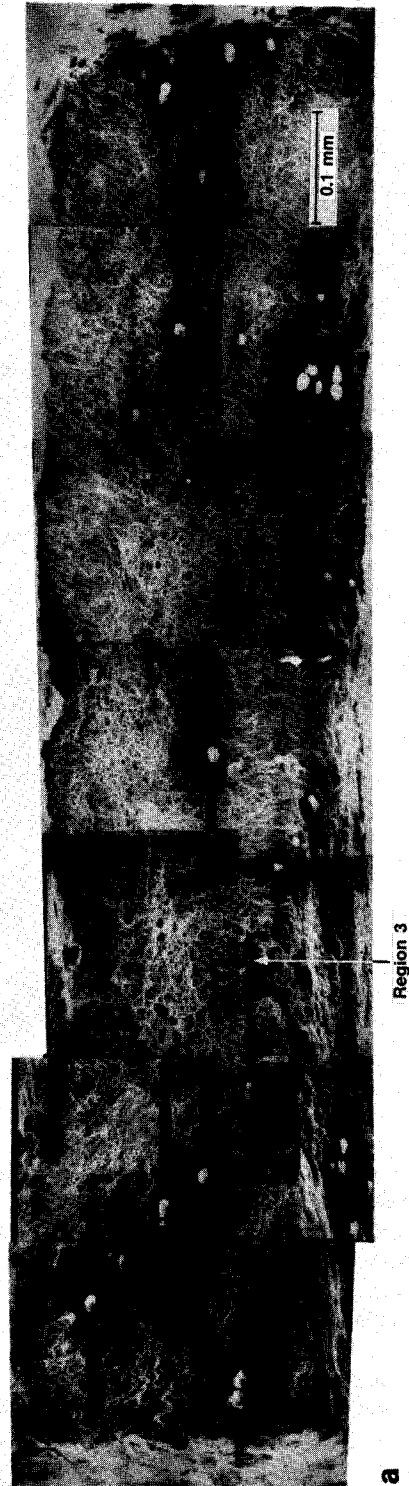
The fracture surface of specimen D-1 reveals several interesting features. As shown in figs. 5a and 5b, approximately 5 to 6% of the fracture surface is IG in nature; otherwise the specimen ruptured in the ductile mode. Several particles were observed in the grain boundary regions (fig. 5a). EDS analysis (fig. 5c) revealed particle X to contain aluminum and nickel, suggesting the possible formation of a high-strength, low-ductility  $Ni_3Al$  intermetallic compound. Analysis of a second particle Y in the IG region showed the presence of zinc (fig. 5d), while a third particle Z contained sulfur (fig. 5e). According to Old [5], zinc is known to cause liquid metal embrittlement of austenitic stainless steels, while sulfur causes stress corrosion cracking (SCC).

Fig. 5a. SEM micrograph of the fracture surface of specimen D-1. Region 3 shows IG fracture.

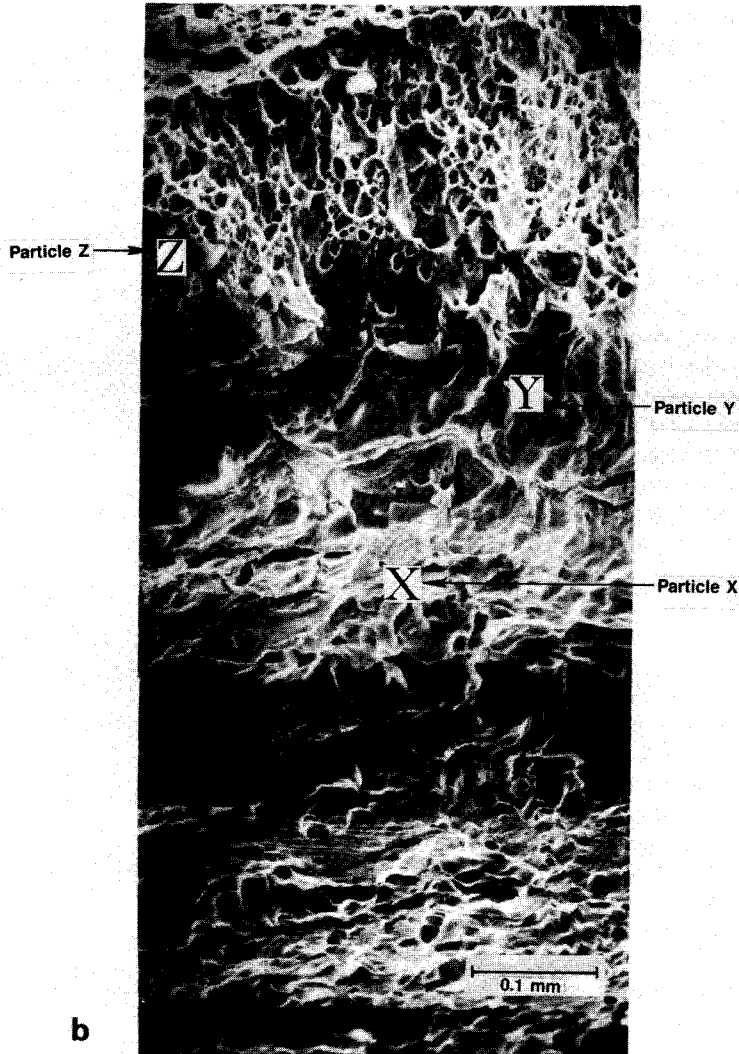
Fig. 5b. SEM micrograph of IG region 3 fracture surface of specimen D-1 at higher magnification.

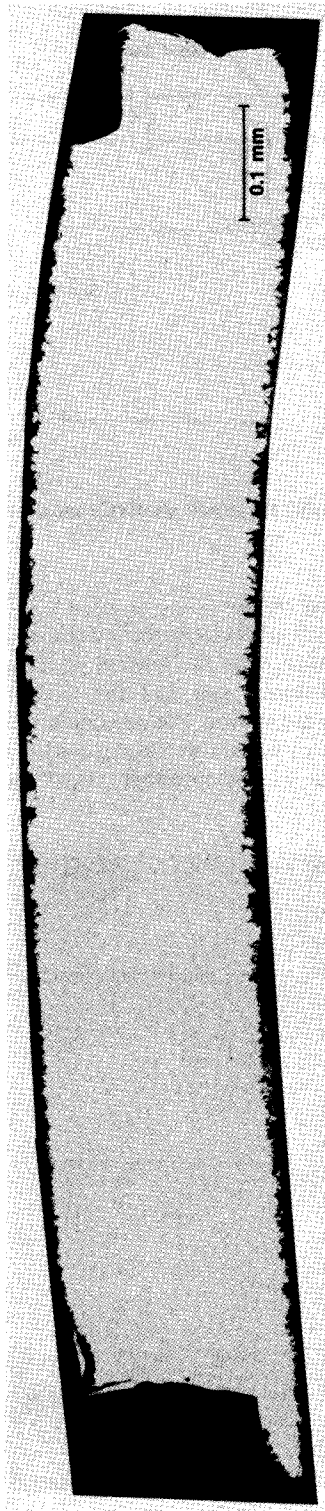
A slight trend in the average penetration depth of the grain boundaries with fluence was observed. For specimen C-2 with the highest fluence, clear grain boundary penetration was observed even with significant surface corrosion (see fig. 6). The grain boundary penetration was not distinct, however, for specimens D-1 and E-3, as the penetration was masked somewhat by general surface dissolution. For the low fluence sample (specimen F-3), clear grain boundary penetration was observed with little surface corrosion.

Fig. 6. Corrosion test metallography of specimen C-2.

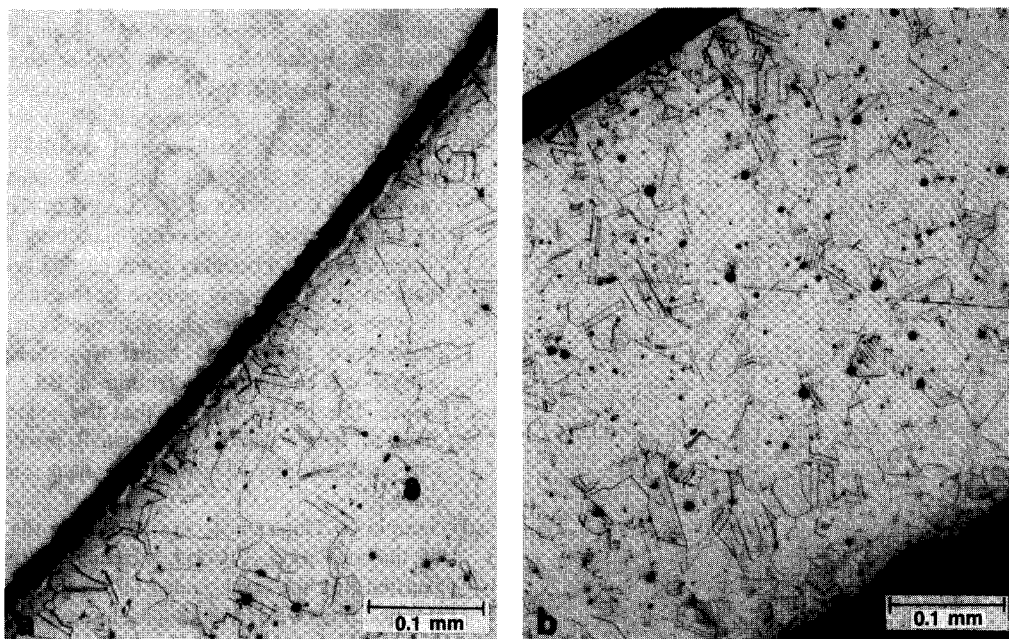
At the position near the bottom of the absorber (fig. 9a), it can be seen that the gap is much smaller than at the 15 cm position (fig. 9b). Also, rougher edges of the absorber outside diameter (OD) and cladding ID surfaces indicate that contact occurred at reactor temperature. When the cold-to-hot gap change is considered, contact would be expected at this position, whereas contact would not be predicted at the 15 cm position. There was no evidence of cladding wear in this sample, and the average cold diametral gap measured at this location was  $1.3 \times 10^{-3}$  cm. At the 15 cm position (fig. 9b) there is no evidence of absorber/cladding contact at temperature since the absorber OD and cladding ID surfaces are relatively smooth, and there is also no evidence of cladding wear. The average (cold) diametral gap measured at this location was  $4.5 \times 10^{-3}$  cm. The specified nominal as built gap was  $7.6 \times 10^{-3}$  cm.

Fig. 9. Optical micrographs for reference tip 16: a. widest gap, bottom of absorber, b. widest gap, 15.24 cm from bottom of absorber.

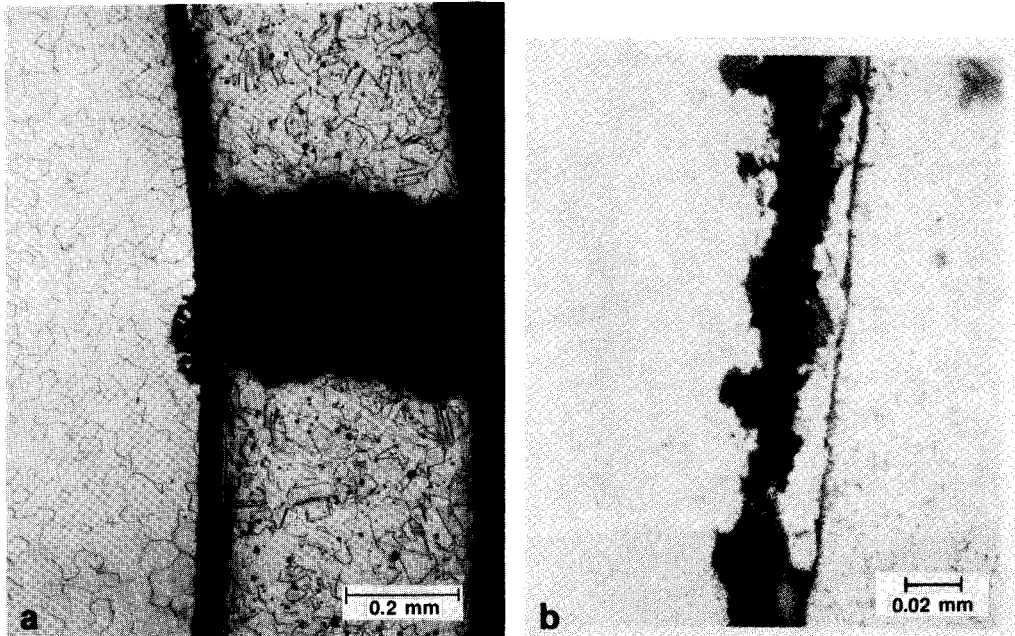
Fig. 10 shows some of the significant features of the 3.2 cm sample (sample M). Fig. 10a shows the full cross section of the penetrating crack. Local oxidation of the absorber can be seen opposite the crack, and the relatively smaller arc length of the absorber oxidation relative to the crack width suggests that the crack was opened further during rod cutting. Fig. 10b shows adherence of the absorber to the cladding near the crack, which is evidence of hard contact and perhaps chemical

interaction (diffusion) between the absorber and cladding. The cracking is IG in nature. Another significant finding is that the cladding wall was thinned approximately  $5.0 \times 10^{-3}$  cm near the crack, as determined from cladding thickness measurements. The measured average cold diametral gap (after correcting for crack width) is  $-6.6 \times 10^{-4}$  cm, which indicates a small amount of absorber/cladding interference in the cold condition.

Fig. 10(a). Optical micrograph of sample M from the cracked tip at 3.2 cm from bottom of absorber. (b). Optical micrograph of sample M from the cracked tip at 3.2 cm from bottom of absorber.

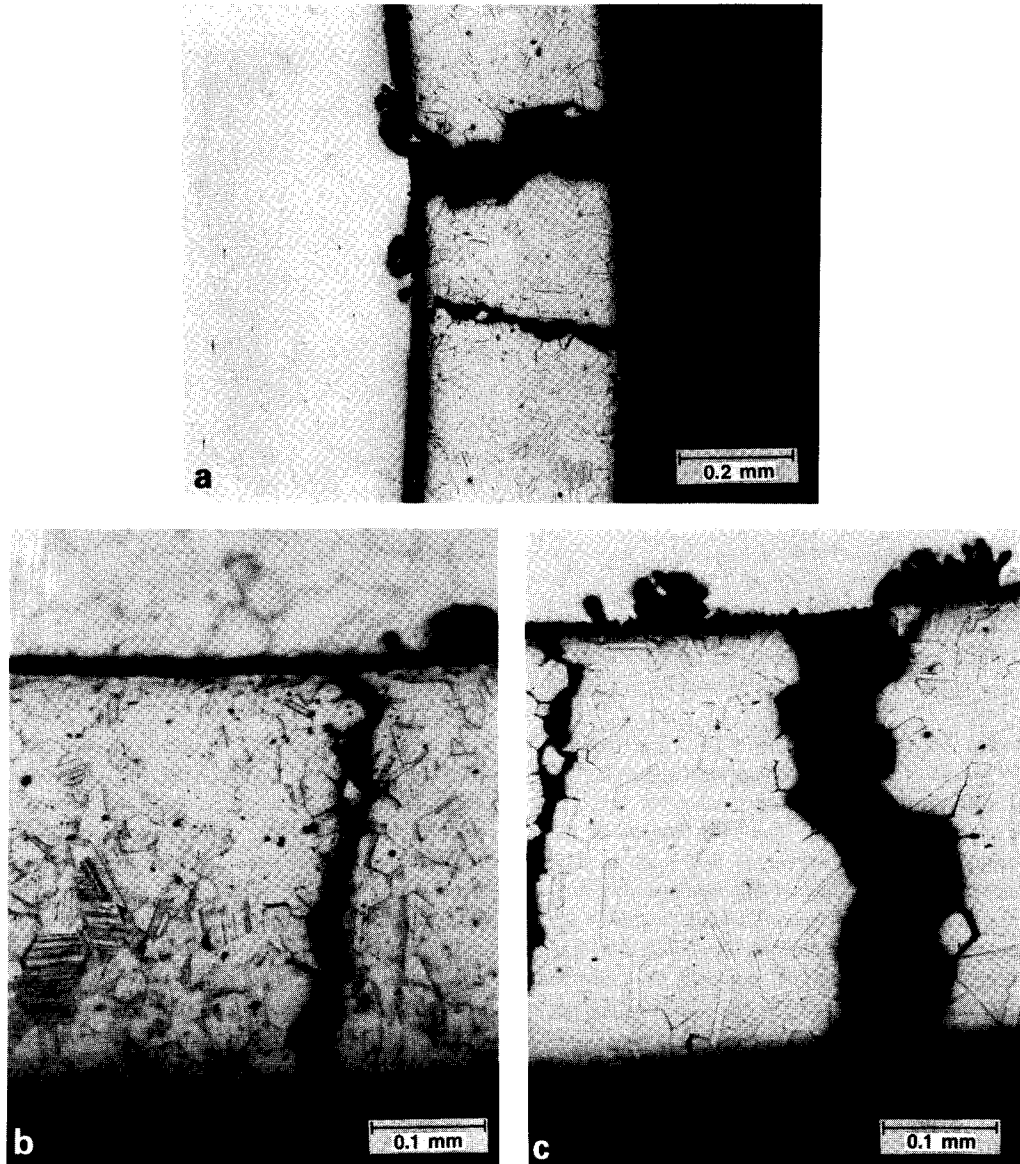
Fig. 11 shows optical micrographs of sample L from the cracked tip near the bottom of the absorber. Two

radial cracks, one of which is much narrower, are evident. Possible incipient cracks can also be seen at the OD of the cladding; however, it cannot be definitely concluded that the crack initiated at this location or from the OD, since the incipient cracks may have been due to a branching process from a higher elevation. No such incipient defects are seen at the 3.2 cm elevation. At the lower elevation, the IG nature of the crack is evident, and loose grains can be seen. Also, significant cladding wear of approximately  $1.0 \times 10^{-2}$  to  $1.3 \times 10^{-2}$  cm can be observed near the cracks by measuring the remaining cladding thickness. The measured average diametral gap (after correcting for crack width) is  $1.1 \times 10^{-3}$  cm, which is very similar to that for the reference tip.

Fig. 11. Optical micrographs for sample L in the cracked tip near the bottom of the absorber: a. shows two radial cracks, b. shows possible incipient cracks on the OD, c. shows the two radial cracks at higher magnification.

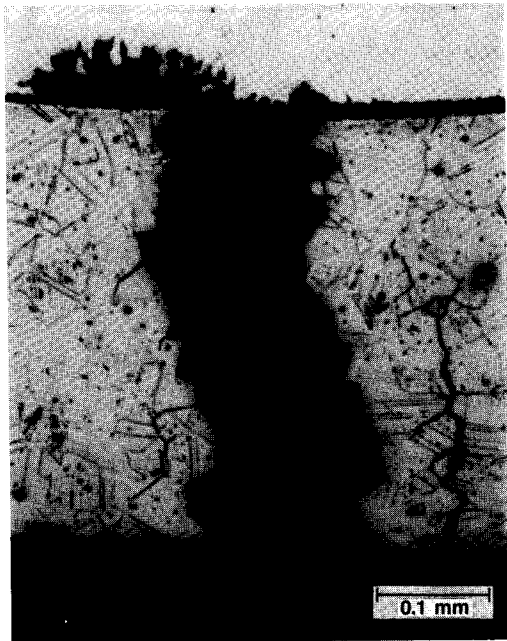
- (b) Sample N. This sample was adjacent to sample L, near the bottom of the absorber, and facing up the rod. Metallographic examination results are shown in fig. 12. This figure shows that the second, smaller IG crack (seen in sample L, fig. 11) is now only part way through the cladding on the outside. This sample is only about 0.13 cm from sample L. The measured gap (corrected for crack width) from this sample is  $-1.35 \times 10^{-3}$  cm, and the amount of cladding wear at the crack location is approximately  $1.02 \times 10^{-2}$  cm.

Fig. 12. Optical micrograph of sample N in the cracked tip near the bottom of the absorber.

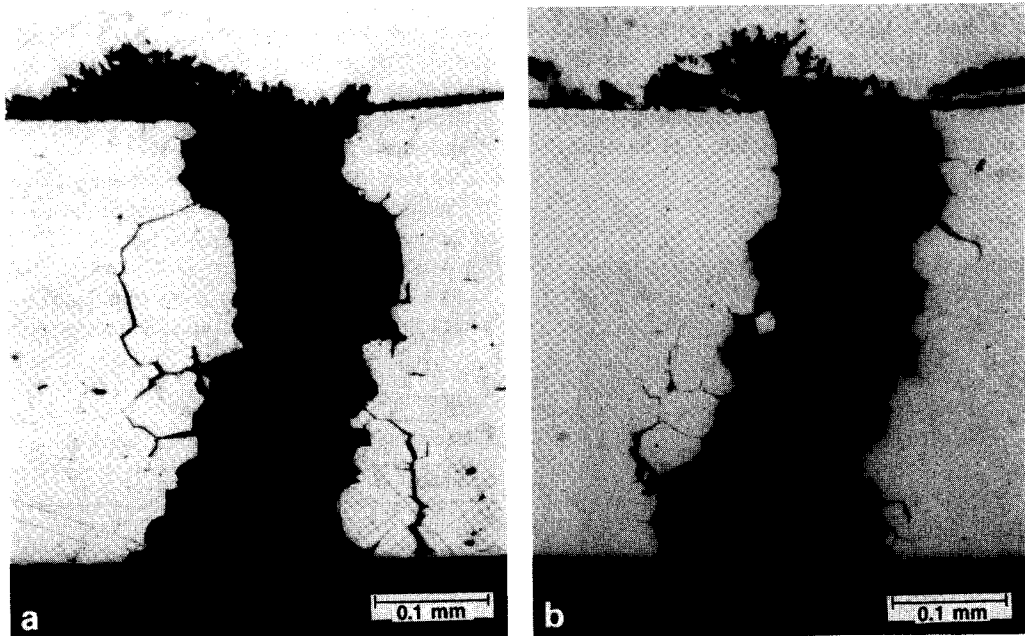
Fig. 13 shows the results of sequential grinding on sample N. After grinding away 0.12 cm, the second crack on the outside is even smaller and is joined with the primary crack (fig. 13a). A large secondary crack which joins the primary crack at both ends is also visible along with several smaller branching cracks. Fig. 13b shows the crack pattern after another  $3.3 \times 10^{-2}$  cm of grinding. The second crack no longer exists, but several branching cracks on either side of the primary crack can be seen.

Fig. 13. Optical micrographs showing sequential grinding on sample N in the cracked tip near the bottom of the absorber: a. shows the crack pattern after 0.12 cm of grinding, b. shows the crack pattern after  $3.3 \times 10^{-2}$  cm of grinding.

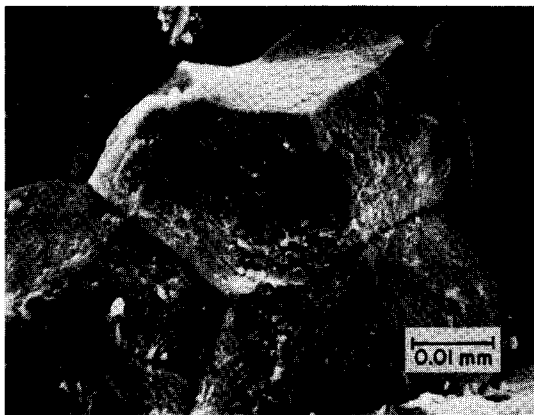
The fracture morphology of the cracked rod is shown in fig. 15. The cracked cladding exhibited no ductility.

The crack is clearly IG in nature, and loose grains are evident. Elemental analysis of the inside and outside surfaces of the cladding showed the presence of silver on the inside surface, which is an indication of absorber/cladding contact. An elemental analysis of the inside and outside surfaces is given in table 5. It is instructive to compare these data with the chemical analysis of particles found in the fracture surface of the miniature tensile specimens machined from reference rod 16. These data are summarized in table 6. The ID surface of the cracked rod contained Al and Mn and these elements were also found in the miniature tensile specimens. The presence of Ag on the ID surface of the cracked rod may be due to diffusion after contact with the absorber.

Fig. 15. SEM fracture surface of cracked rod 11.
