## A PHENOMENOLOGICAL INVESTIGATION OF IN-REACTOR CRACKING OF TYPE 304 STAINLESS STEEL CONTROL ROD CLADDING

Wear and hairline cracking have been observed in the cladding of rod cluster control assemblies (RCCAs) in several pressurized water reactors (PWRs). The cracks are typically about 10 cm long, oriented longitudinally, and located in the high-fluence region of the rods. This paper reports our findings concerning the cause and nature of the cracking mechanism. Data from miniature-specimen tensile tests, scanning electron microscopy (SEM) investigations, and corrosion tests on control rod cladding that cracked in-service are reported along with the results of a hot cell investigation of an actual in-service crack. Possible causes of failure and comparisons to literature data are also presented.

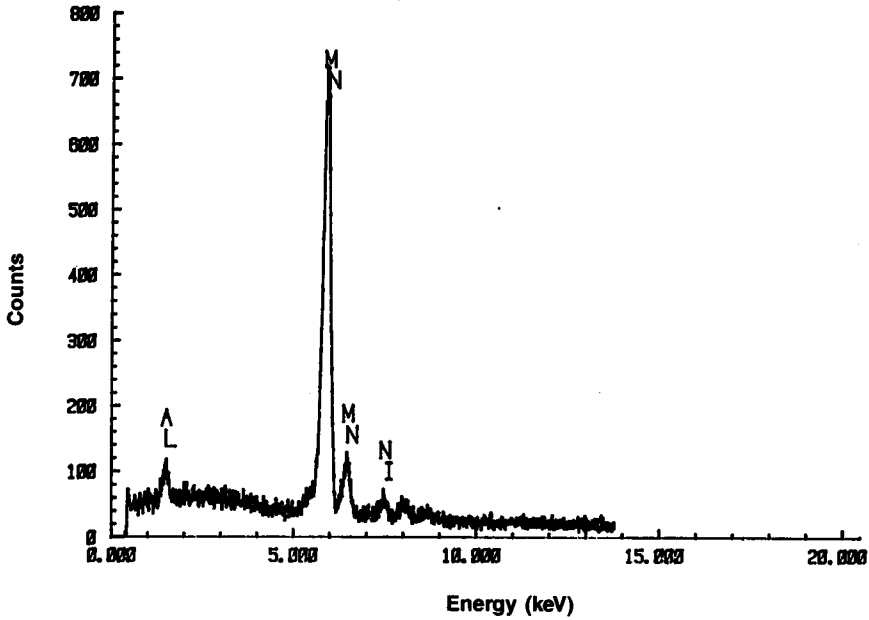
D1 Area #1 Part. X

Fig. 5c. EDS analysis of particle X found in specimen D-1.

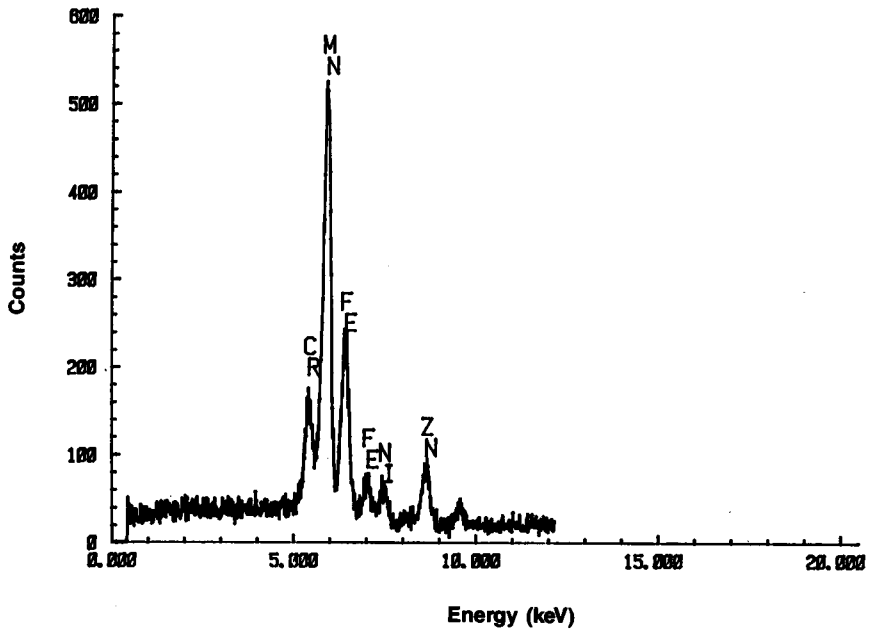
D1 Area #1 Part. Y

Fig. 5d. EDS analysis of particle Y found in specimen D-1.

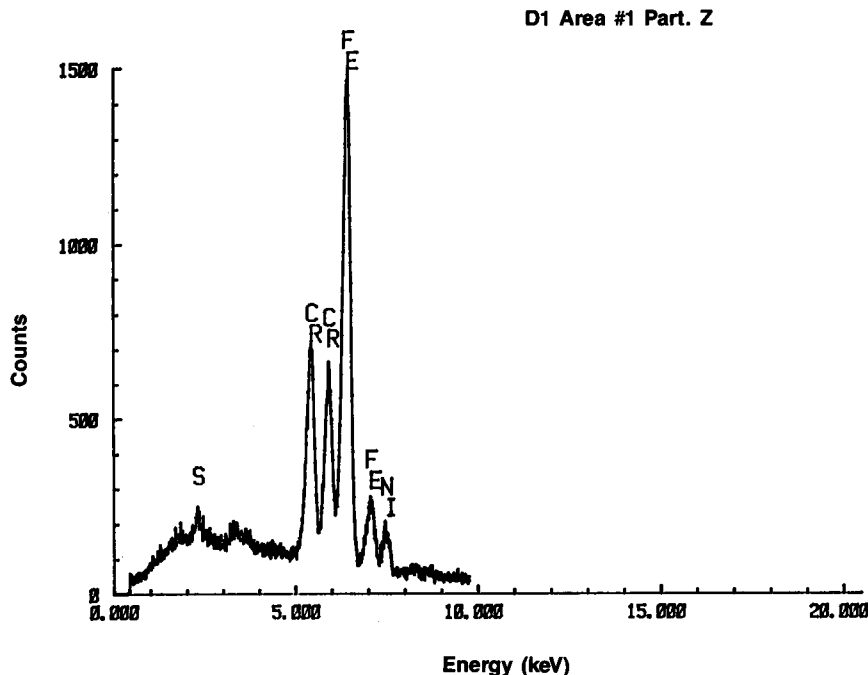
Fig. 5e. EDS analysis of particle Z found in specimen D-1.

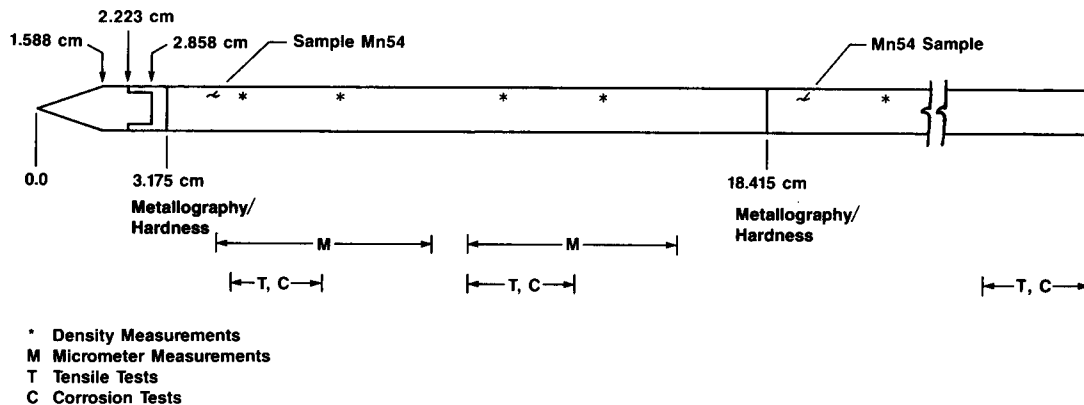
Fig. 7. Sectioning diagram for reference rod 16.

Fig. 7 shows the sectioning diagram for the reference tip (rod 16), indicating the locations of the various samples. Hardness measurements were performed on the metallographic samples near the rod tip and along the length of the rod. Micrometer and density measurements and a nitric acid-dichromate corrosion test were also performed near the tip of the rod. Fig. 8 shows the locations of the metallographic and the SEM samples for rod 11.

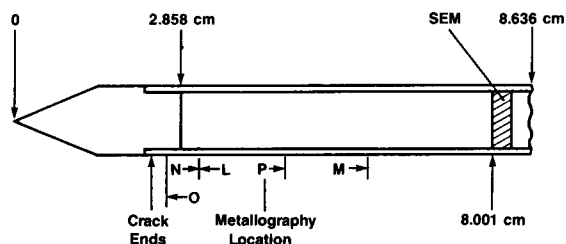
Fig. 8. Sectioning diagram for cracked rod 11. Sequential grinding performed at locations L, N, and O.

from the bottom (sample M). After initial observations, additional samples were taken to further study the cracked tip (see fig. 8).

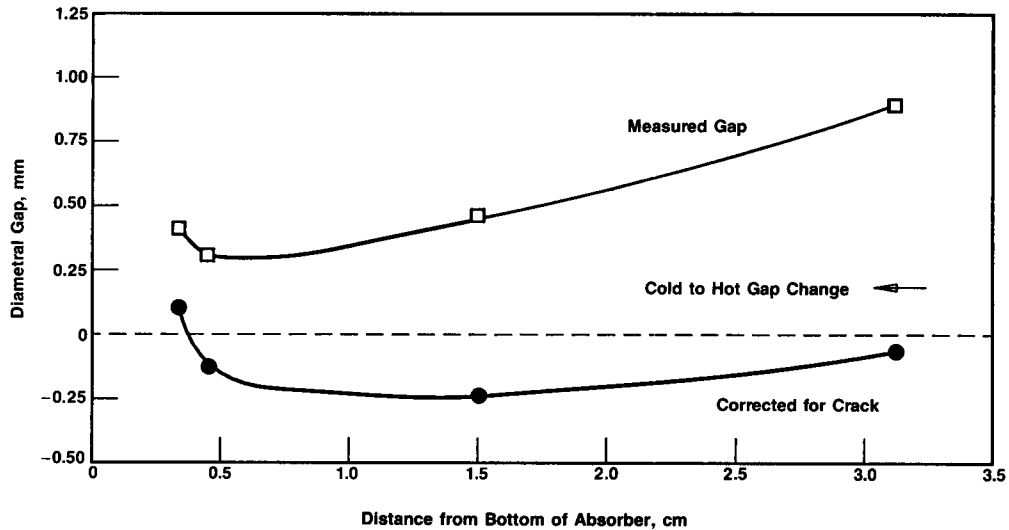
Fig. 14. Absorber/cladding gap for cracked rod 11.

Fig. 14 is a plot of the absorber/cladding gap as a function of distance from the bottom of the absorber. Both the 'as-measured' gap and the 'corrected' (for crack width) gap are shown. The maximum interference ( $-2.41 \times 10^{-3}$  cm) occurs at approximately 1.52 cm from the bottom of the absorber. This interference

would increase approximately  $1.78 \times 10^{-3}$  cm (to approximately  $-4.19 \times 10^{-3}$  cm) at temperature in-service because of differential thermal expansion of the absorber and cladding materials. The interference at the time of actual cracking, however, is not known. The 1.52 cm location is also that of the maximum crack width in-pile, as determined from the oxide width in the absorber near the crack. Therefore, it is possible that the crack started at this location; however, it is uncertain whether the crack started on the cladding ID or OD.

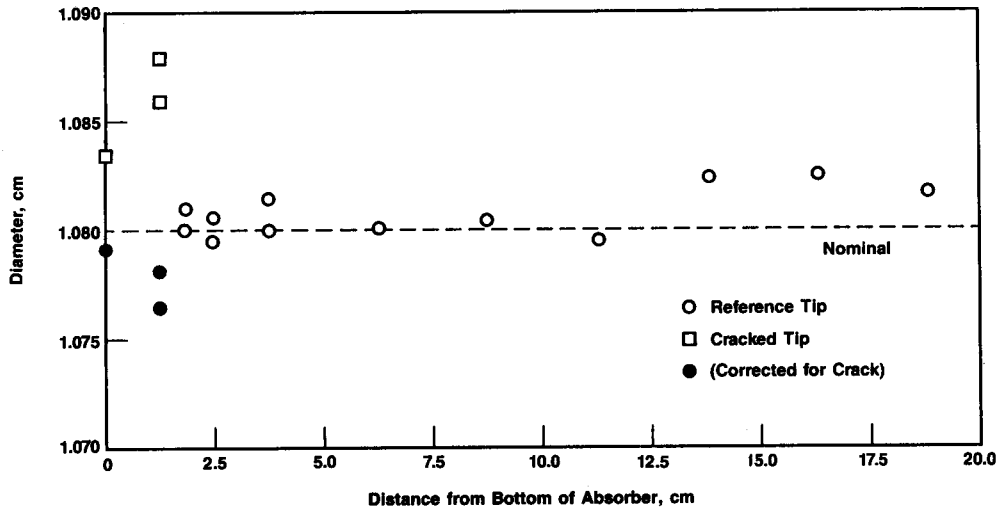
Fig. 16. Knife edge profilometry diameter measurements for rods 11 and 16.

Profilometry diameter measurements using a knife-edge stylus (to eliminate off-center effects) are shown in fig. 16. The cracked tip diameters were corrected for the crack width from lead imprint measurements. There is no evidence of cladding permanent strain near the tip, the diameter is within the as-built tolerance range, and ovality, also evaluated at several locations near the tip, is less than  $1.27 \times 10^{-3}$  cm.

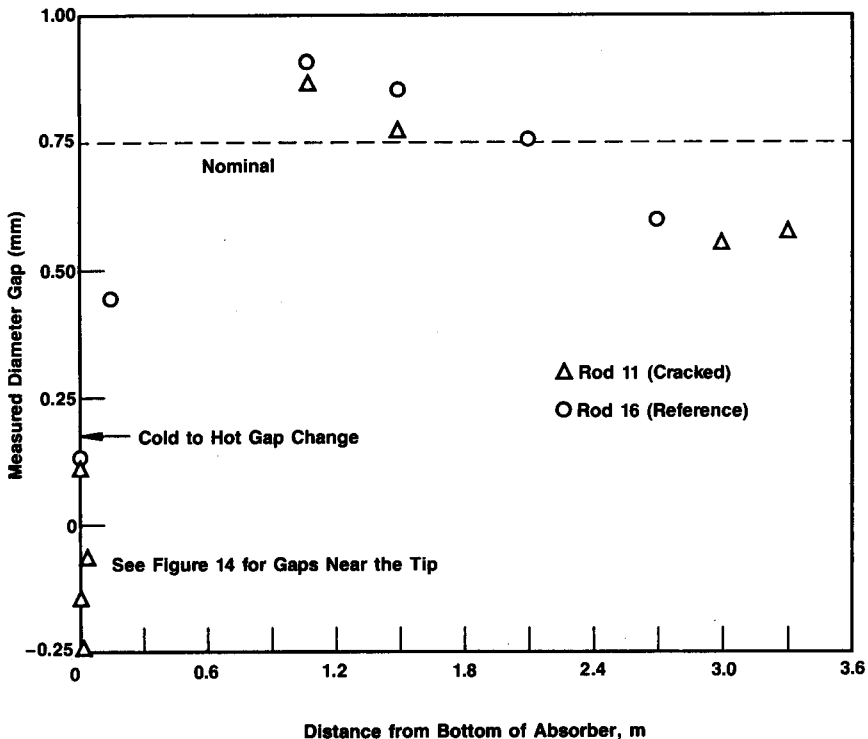
Fig. 17. Measured diametral gap for rods 11 and 16.

Fig. 17 shows the measured cold absorber/cladding diametral gap as determined from metallographic

examination along the entire length of rods 11 and 16. Included are the gaps measured at the tips (fig. 14). As can be seen, these gaps are greatly reduced in the tip region. (Gap sizes in the cracked tip were corrected for the crack width, as discussed previously.) Figs. 14 and 17 also show the estimated cold-to-hot gap change due to the higher thermal expansion of the absorber relative

per  $10^{21}$  n/cm<sup>2</sup>, which agrees reasonably well with the value reported previously [8]. The swelling in the reference rod at approximately 3.18 cm from the bottom of the absorber (1.5% volume change) is about half that determined from the micrometer measurements (fig. 18). This suggests that partial gap closure may have been due to some other mechanism such as plastic deformation (yielding) of the absorber due to axial forces during operation. The axial variation in the diametral gap shown in fig. 17 indicates that some axial redistribution of the absorber material may have occurred in service.

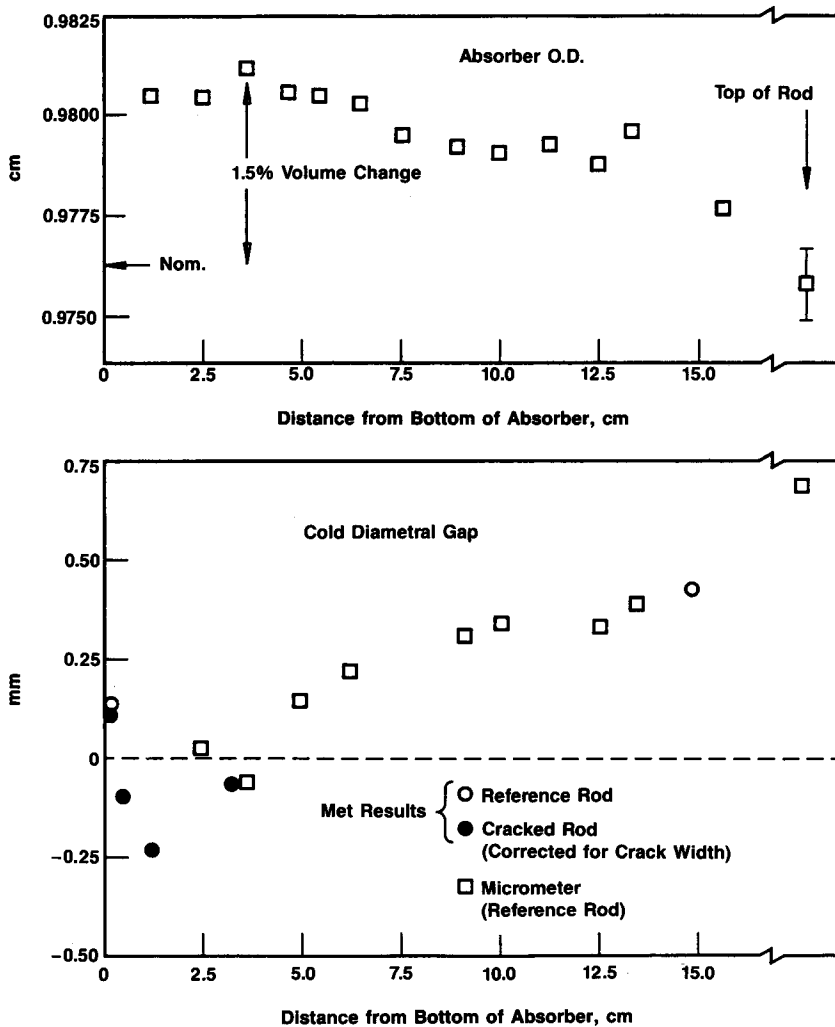
Fig. 18. Absorber OD for rod 16 and cold diametral gap as a function of distance from the rodlet tip for rods 11 and 16.

The results of these measurements are plotted in fig. 18. The absorber/cladding gap was calculated from the measurements and compared with previous metallography results; these results are also shown in that figure. The micrometer measurements agree well with the metallographic results at the 15.2 cm position and indicate that the gap did close near the bottom of the rodlet. From the absorber OD measurements, one can see that the Ag-In-Cd increased in size near the tip. This dimensional change corresponds to approximately 1.5% swelling relative to nominal dimensions, as indicated on the figure.

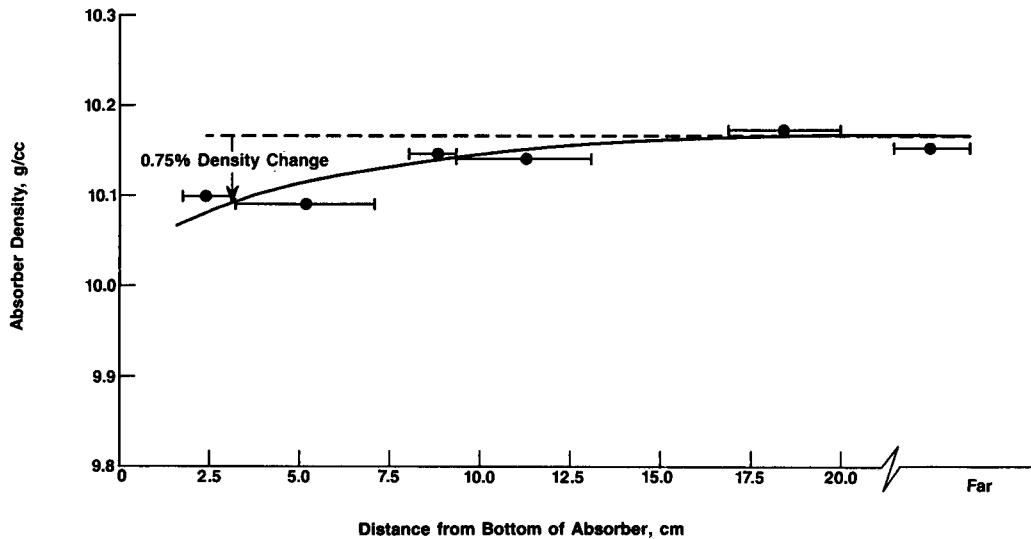
Fig. 19. Absorber density measurements for reference rod 16.

The density data are plotted in fig. 19. The density measured at the top of the rod agrees well with the

unirradiated density of 10.17 g/cc [7]. The swelling near the bottom (0.75% density change) corresponds to an estimated fast fluence ( $E > 1.0$  MeV) of approximately  $5 \times 10^{21}$  n/cm<sup>2</sup>, resulting in a swelling rate of 0.15%

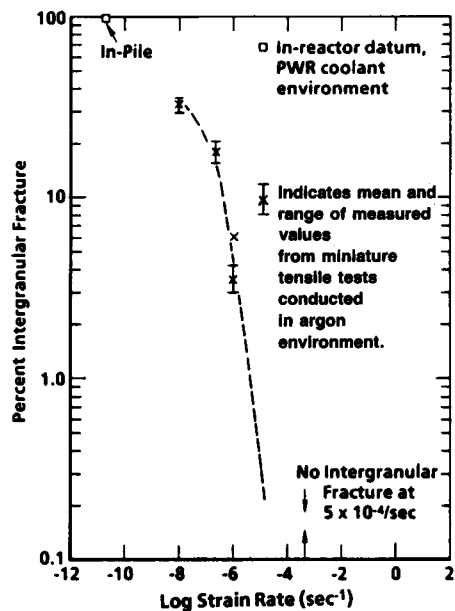
Fig. 20. Percentage IG fracture versus strain rate for irradiated cladding tensile tests at 588 K.

Based on the results of the miniature tensile tests of irradiated cladding material in an inert environment, irradiation alone appears sufficient to render the cladding susceptible to IG cracking. The ID surfaces of the specimens tested were not exposed to coolant. Fig. 20 shows the percent IG fracture of irradiated cladding in an inert atmosphere as a function of strain rate. Autoclave tests representative of a typical PWR coolant would have to be performed at low strain rates to determine any contribution of the environment to the in-pile cracking. Such tests could determine the extent to which stress corrosion plays a role in the in-pile cracking mechanism.

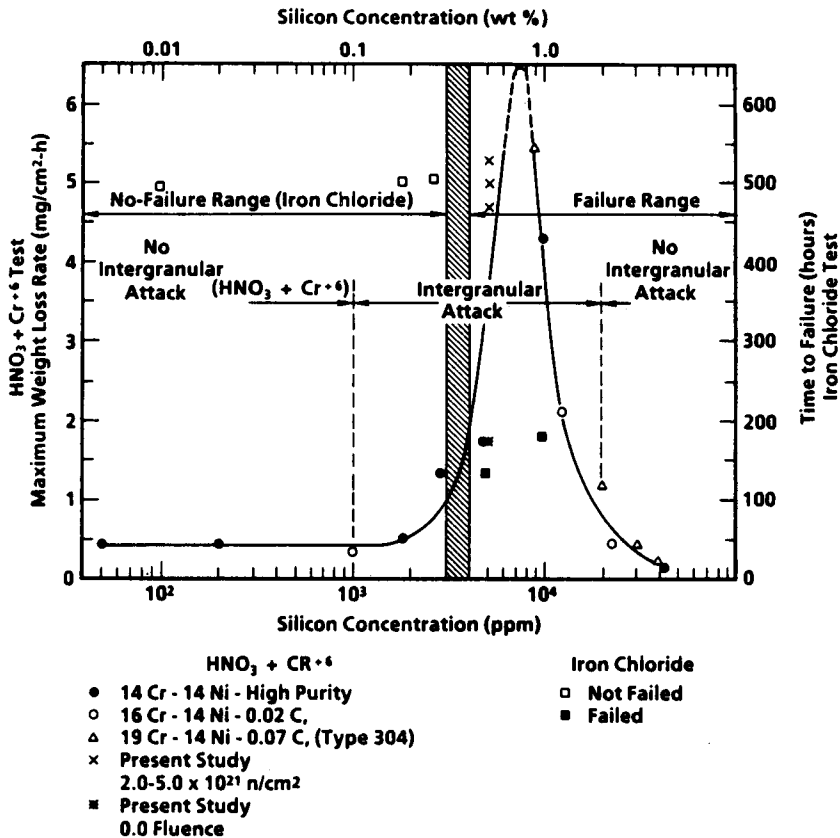
Fig. 21. Effect of silicon additions on the corrosion resistance of nonsensitized, high-purity SS alloys [10]. Data from present study are included.

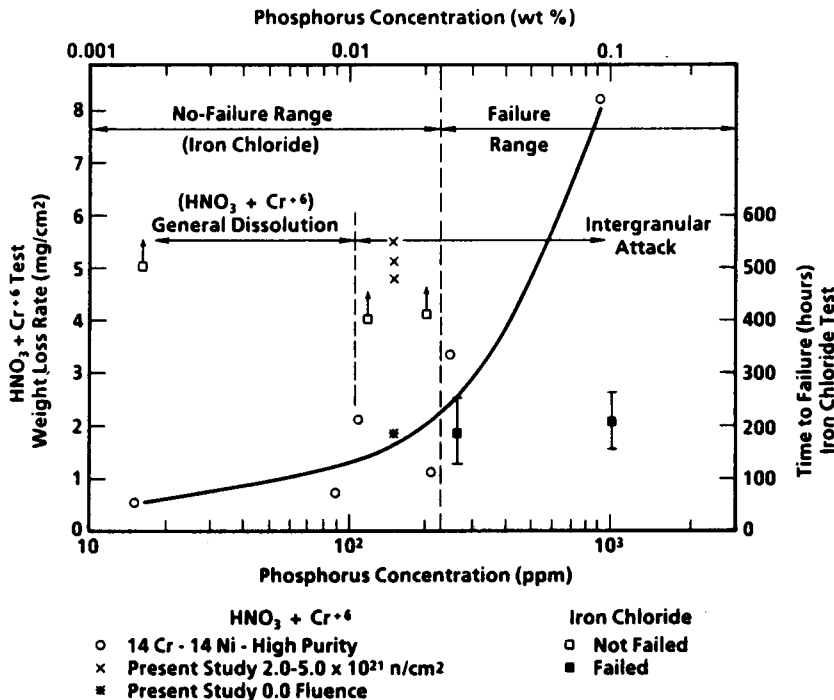
Fig. 22. Effect of phosphorus additions on the corrosion resistance of nonsensitized, high-purity SS alloys [10]. Data from present study are included.
