## Percent Shear Area Determination in Charpy Impact Testing

M. P. Manahan, Jr.<sup>\*</sup>, C. N. McCowan<sup>\*\*</sup>, and M.P. Manahan, Sr.<sup>\*</sup>

**Abstract:** The Charpy test is used throughout the world in a wide range of industries because of its low cost and the fact that notching and dynamic loading produces a crack tip stress field, which is conservative for many applications. As a result of its widespread use, there is a compelling motivation to extract as much data as possible from the Charpy test. In a Charpy impact test, three key measurements are typically made: total absorbed energy, lateral expansion, and percent shear fracture area. At present, the measurement of absorbed energy and lateral expansion is quantitative and well defined, but the methods used by most laboratories in the measurement of percent shear are qualitative and imprecise. This is ironic for a 100-year-old test because, as discussed in this paper, it can be reasonably argued that percent shear is the most fundamental and physically meaningful of the three Charpy parameters for brittle fracture characterization. Digital image analysis for shear fracture area is shown to be accurate, pre

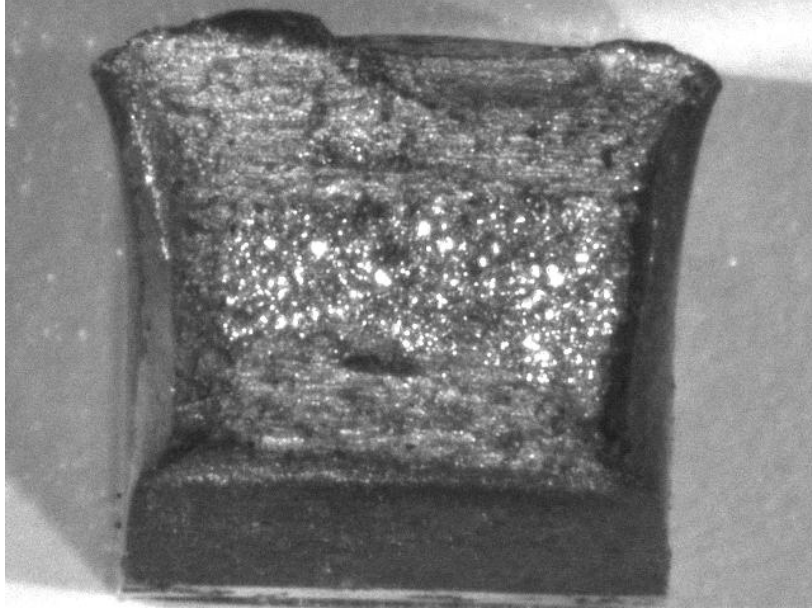
**Figure 1 Textbook Fracture Surface Showing Bright Shiny Faceted Region Surrounded by Ductile Fracture Area.**

Before discussing the analysis for SFA measurement methods, it seems appropriate to present the argument for SFA as an important and fundamental Charpy parameter. In order to set the proper context for this discussion, we must first define the need for the Charpy test. In particular, what is needed is a simple and cost-effective test that can provide useful data for protection against brittle fracture in components and structures. Of course, the Charpy test can also be used for protection against ductile fracture, which is important in applications such as upper shelf energy drop in nuclear pressure vessels due to neutron irradiation. It is also beneficial as a comparison test for ductile fracture evaluation in general. However, we will limit our current discussion to brittle fracture applications for consideration of SFA measurement technology.

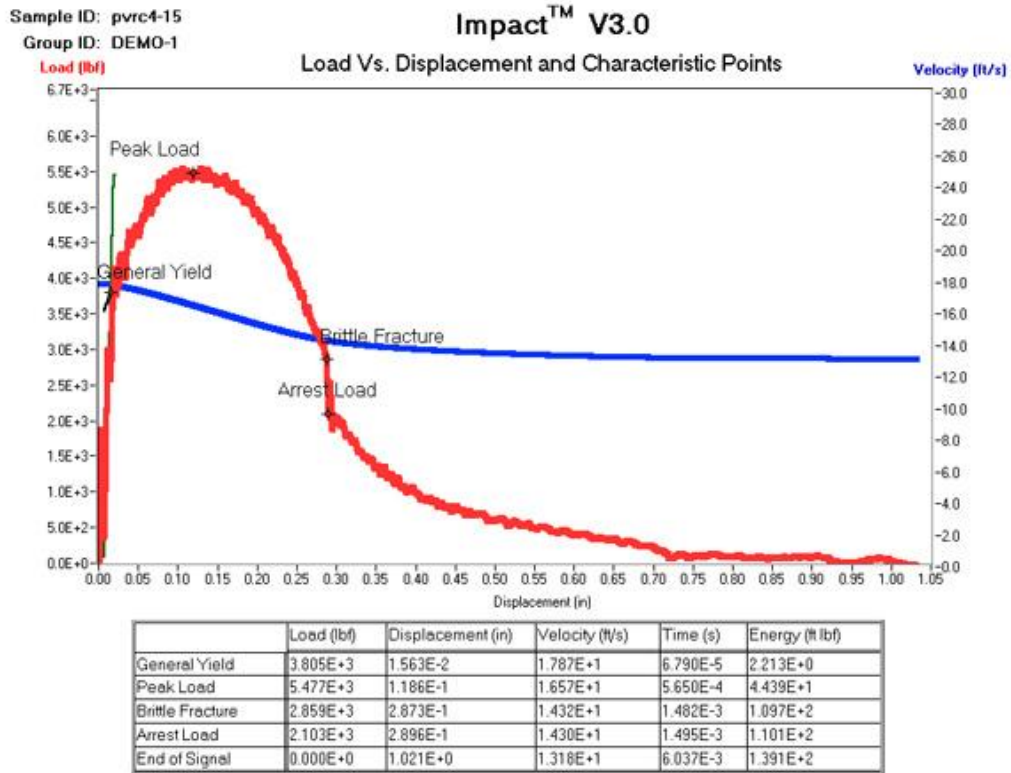
**Figure 2 Example of an Instrumented Striker Signal for a Charpy Test Conducted in the Transition Region, Showing Sudden Drop in Load Associated with Brittle or Fast Fracture Event.**

All body-centered-cubic materials undergo transitional fracture behavior over some temperature range. This means that the material will be 100% brittle below a certain temperature and 100% ductile above a higher temperature. The intermediate temperature range is referred to as the transition region where the fracture is mixed mode. The traditional definition of mixed mode is a fracture surface where there is one separate region of brittle fracture surrounded by a second region of ductile (fibrous) fracture. An example of mixed mode fracture is shown in Figure 1, and Figure 2 shows the load-deflection behavior observed when a specimen fractures in the transition region. Referring to Figure 2, the crack forms in the specimen at the notch root as the loading increases to the peak load level. Stable crack growth initiates at the notch in the center region where the stress intensity factor is highest and spreads along the root of the notch toward the free surfaces. Just prior to peak load, the stable crack is formed and begins to propagate into the uncracked ligament. The load decreases as a result of the load-carrying area reduction, and the stable crack propagates until the brittle crack initiates. Brittle fracture is signaled by the rapid load drop which indicates the microsecond time scale brittle crack advance.

The remaining energy after brittle fracture is expended in tearing the shear lips and in bending/fracturing the plastic hinge at the rear of the ligament. For tests near the lower shelf, brittle fracture occurs during initial load rise, well before reaching peak load. For tests on the upper shelf, the load-deflection curve is similar to that of Figure 2, but there is no vertical unloading due to brittle fracture. Since the SFA is proportional to the height of the brittle fracture unloading, physically based correlations have been developed to calculate the SFA based on the brittle fracture initiation and arrest loads.

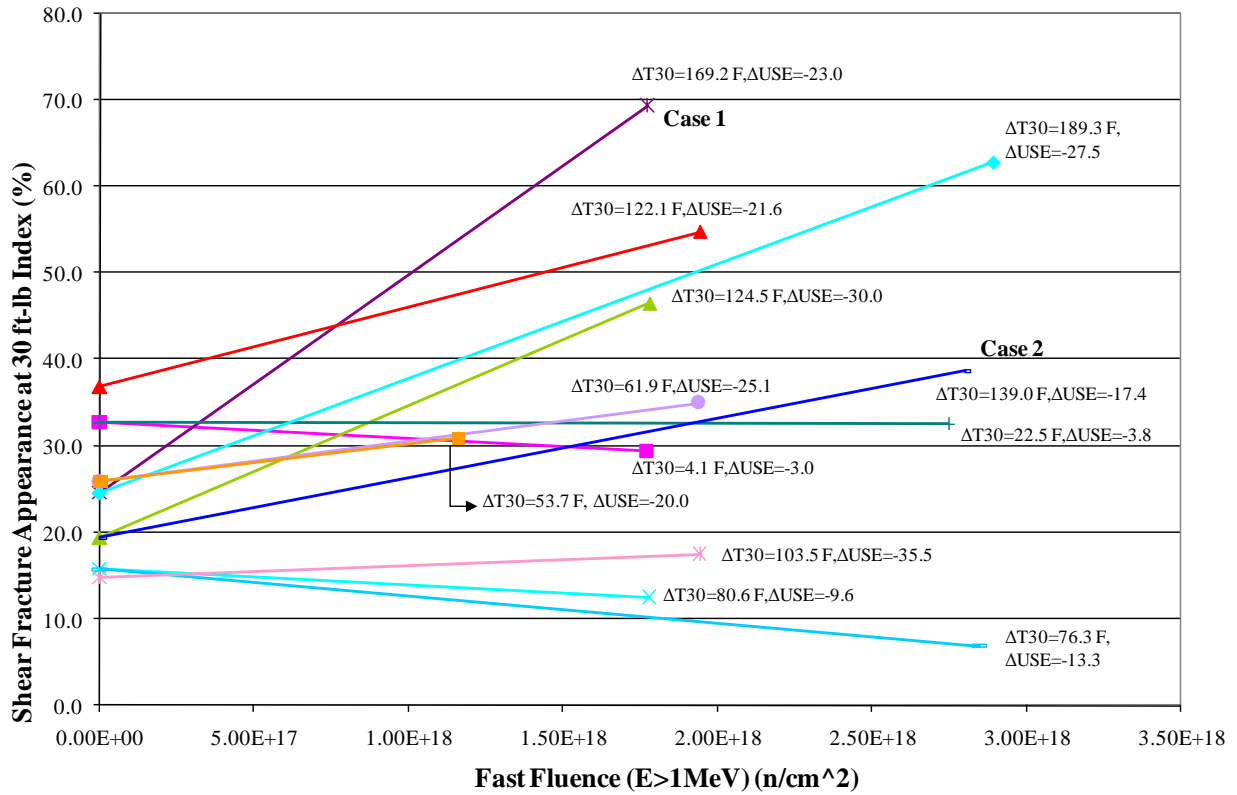
**Figure 3 Plot of SFA at 30 ft-lb as a Function of Fast Neutron Fluence for Irradiated Welds. Note that the Charpy Shift Measured at the 30 ft-lb Index does not Increase Proportionally with SFA.**

One illustration of the drawback associated with the use of the energy parameter is in the nuclear industry where neutron damage causes a shift in the absorbed energy as neutron damage increases. The nuclear industry tracks pressure vessel embrittlement using the 30 ft-lb Charpy index. In general, as a result of neutron damage, the Charpy energy-temperature plot exhibits three changes: the energy-temperature curve is shifted to higher temperatures; the slope in the transition region decreases; and the upper shelf energy drops. As a result of these neutron damage effects, the SFA level corresponding to the 30 ft-lb index, changes continuously throughout the irradiation. This phenomenon is illustrated graphically in Figures 3 through 5. As shown in Figure 3, the change in SFA does not increase proportionally to the Charpy shift measured at 30 ft-lbs ( $\Delta T_{30}$ ). Case 1 shows a material with a low upper shelf energy (USE) and a significant decrease in slope in the transition region. This results in an irradiation induced change in SFA at the 30 ft-lb index of about 45% (see Figure 4). For this particular case, since the shelf drop and slope decrease are large, the 30 ft-lb index crosses the transition curve at a point on the post-irradiation curve that corresponds to a very large SFA level. Case 2 shows a change in SFA at the 30 ft-lb index of about 18% for another weld irradiated to a higher fluence but with a comparable  $\Delta T_{30}$ . In this case, the shelf drop and transition slope change are not large, and the 30 ft-lb index crosses the transition curve at a point on the post-irradiation curve that

corresponds to an SFA level which is close to the unirradiated value. Therefore, there are clearly cases where neutron damage monitoring using an energy index will result in significantly different SFA values in the irradiated materials. This means that the use of a fixed energy parameter can yield neutron embrittlement data that are based on a continuously changing SFA level.

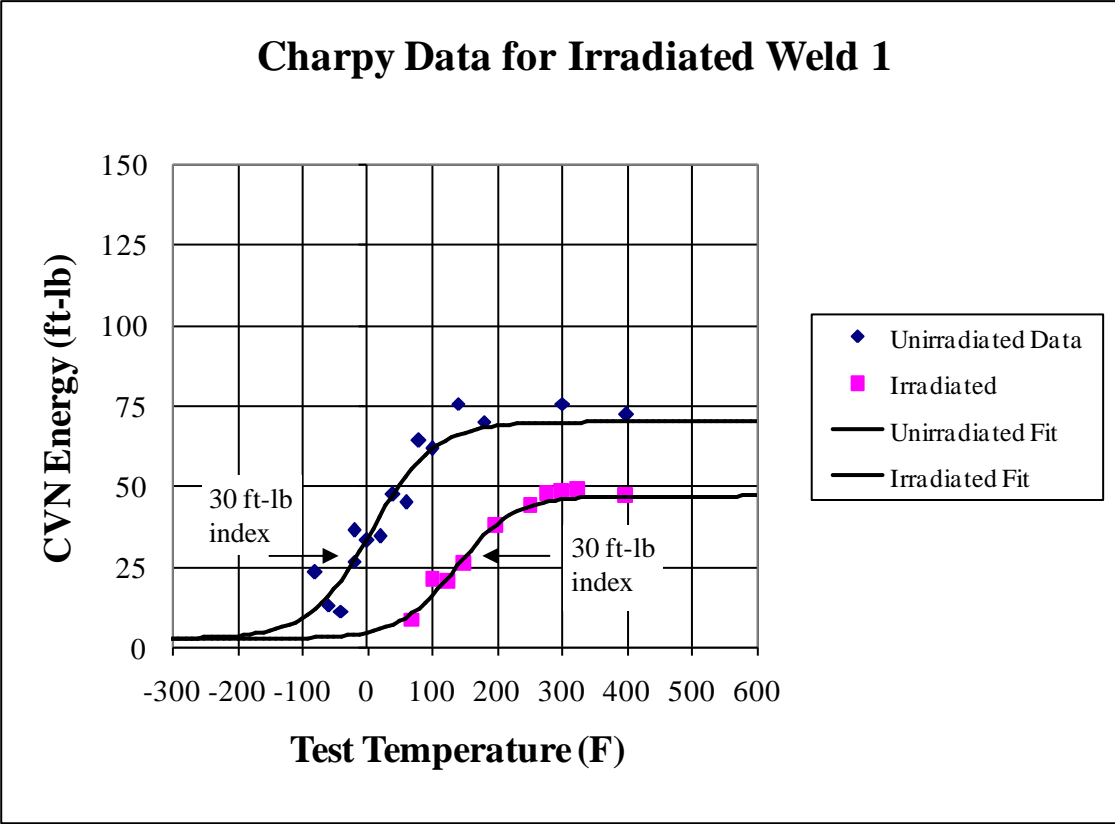
**Figure 4 Plot of the Case 1 Charpy Energy-Temperature Curve. For this Material, the Change in Slope Results in a Large Change (~45%) in SFA at the 30 ft-lb Index.**

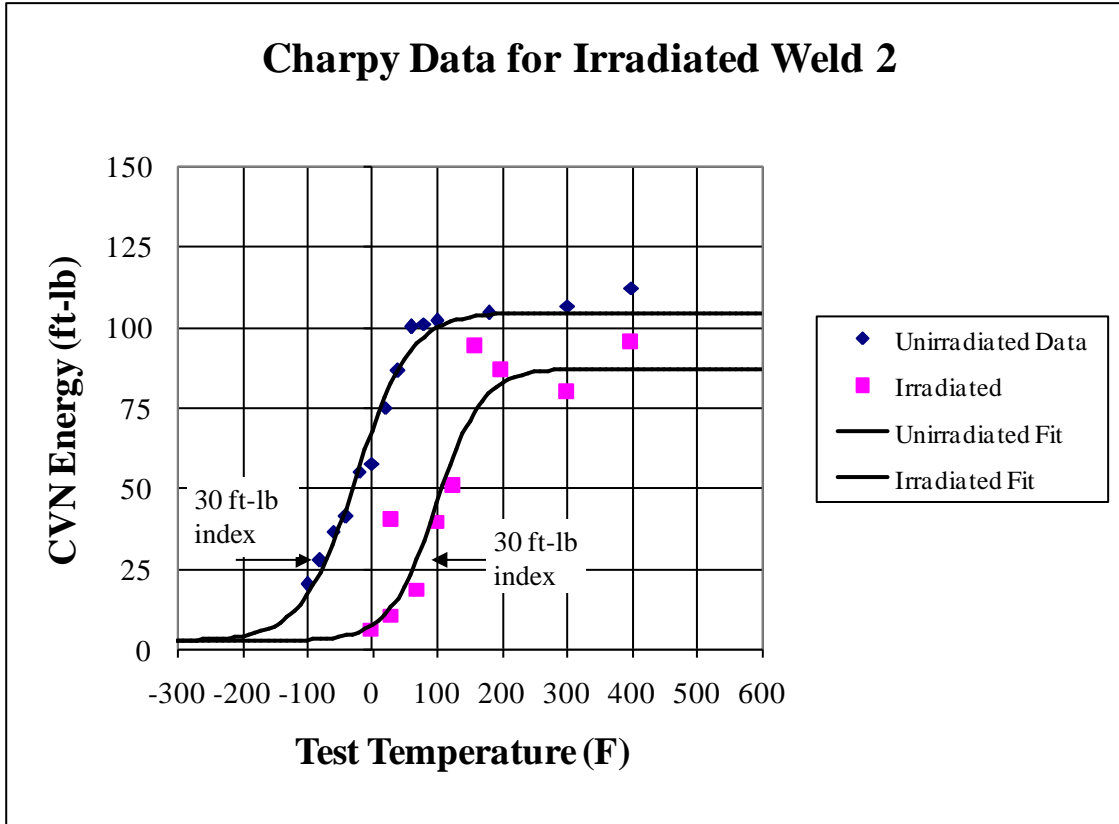
**Figure 5 Plot of the Case 2 Charpy Energy-Temperature Curve. For this Material, the Change in Slope Results in Only a Modest Change (~18%) in SFA at the 30 ft-lb Index.**

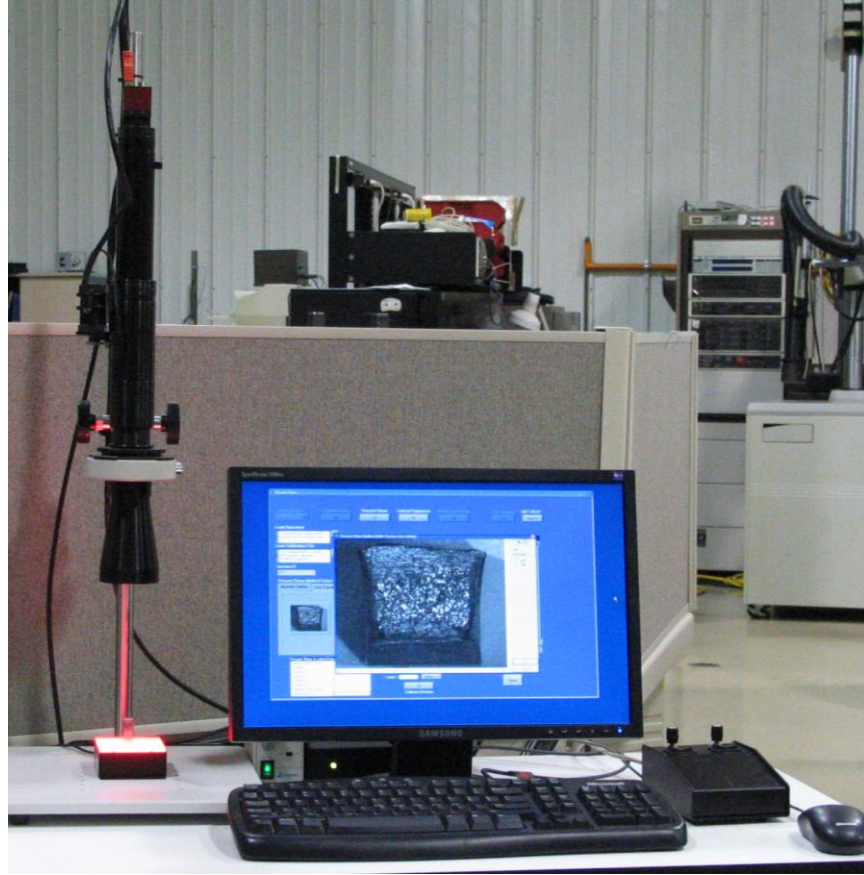
**Figure 6 Image Acquisition and Analysis Hardware for Accurate Percent Shear Measurement.**

Since the focus of the rest of this paper is on digital imaging, it seems fitting that we should define exactly what is meant by digital imaging technology. Digital imaging systems can use image analysis technologies for easy, accurate, and precise measurement of percent shear fracture area. These systems generally consist of a camera, lens, lighting, data acquisition software, and image analysis software. Percent shear measurement via this method involves capturing the image of the fracture surface, outlining the brittle area, and outlining the outside region of the fracture surface. The software automatically integrates the areas to determine SFA. There have been a number of recent advances, such as the use of a telecentric lens (Figure 6) that make these systems more accurate and precise. Even still, the accurate measurement of percent shear is not a changeling application for most modern systems. While the telecentric lens greatly reduces parallax distortion and other optics problems such as lens axis perpendicularity, a recently developed two-dimensional calibration technology eliminates residual errors in the optics. With this technology, it is possible to re-map the pixel grid to yield a nearly undistorted image. In the results reported here, state-of-the-art imaging technology was used that incorporates these features.

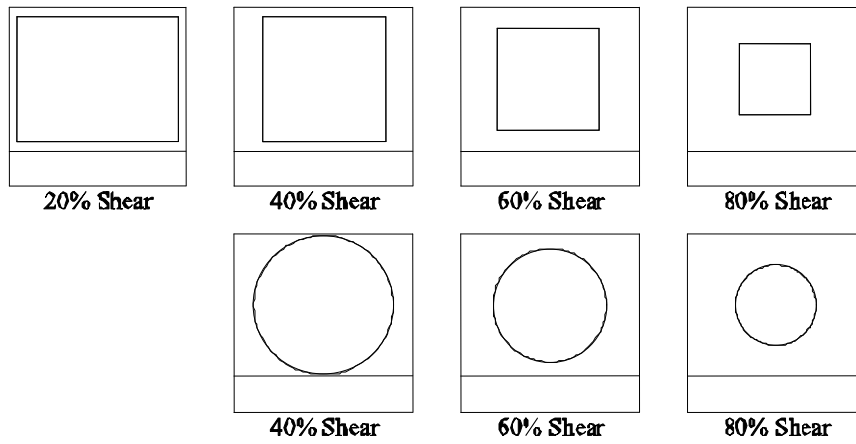
**Figure 7 Enlarged Image of CAD Drawings used for Precision Study.**

To demonstrate the precision of the digital imaging system in a typical shear area application (without using precision-made tooling such as the reticle), the digital imaging system was used to measure the percent shear of a LaserJet printout of a 1:1-scale CAD drawing of a Charpy bar with areas drawn which give 20%, 40%, 60%, and 80% shear (Figure 7). Technical staff members knowledgeable of Charpy impact testing, as well as a non-technical assistant, used digital imaging systems to determine the simulated percent shear areas. The brittle areas were denoted by the inner square or circle center, while the ductile areas were defined by the remaining outer area. Both square and circles were used to simulate the various contours outlined on a typical Charpy bar.

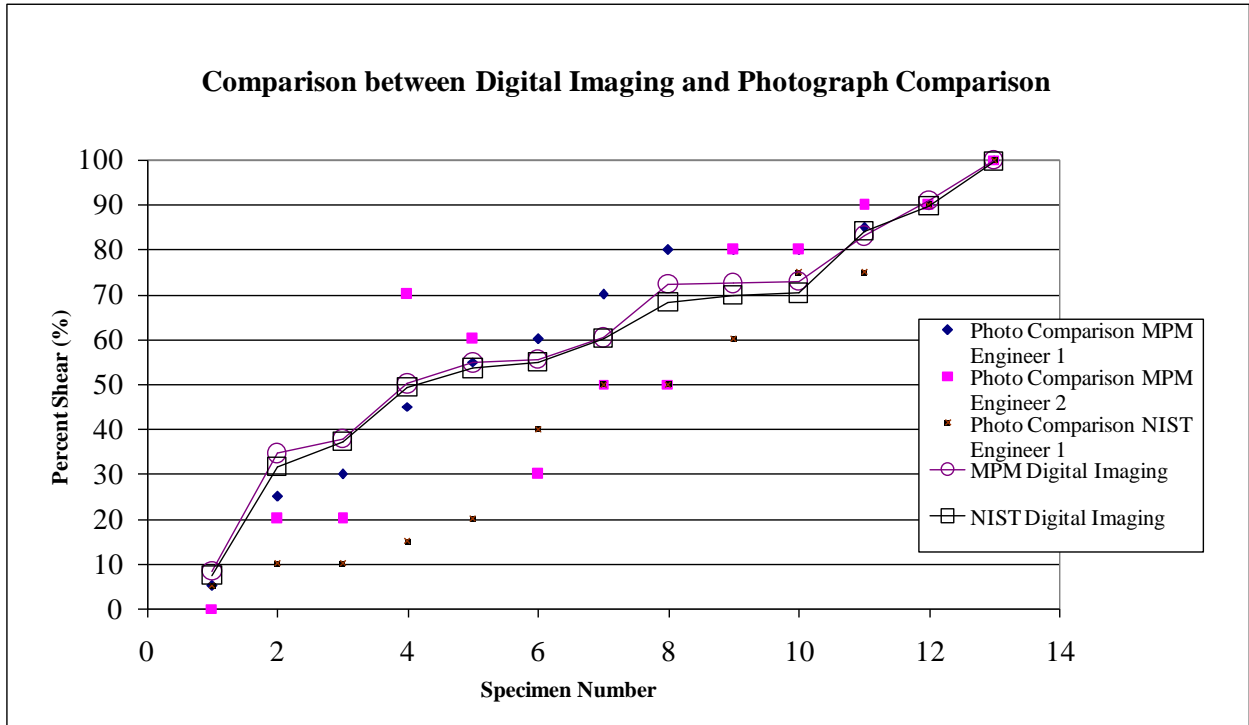
**Figure 8 Comparison of Percent Shear Data Obtained Using Digital Imaging with Results Obtained Using Photograph Comparison Method.**

The results are shown in Figure 8 and in Tables 3 and 4. These results show that, when trained personnel in the Charpy impact testing field use digital imaging to analyze specimens containing definitive brittle areas, the percent shear values are precise. The average percent difference between laboratories was only 1.5 % shear, and the maximum difference for any single measurement was only 4 % shear. Since three engineers were able to obtain very similar results, and since the previous section of the paper has established that any region that can be seen can be accurately integrated to obtain the correct area, we have concluded that the image analysis results are also accurate.

A comparison of the digital imaging data and the photograph comparison method is shown in Table 4. The average difference between the digital imaging result and the photograph comparison method is 19.6 % shear, with the largest deviation being 55 % shear. Figure 8 also shows that photograph comparison results, at percent shear levels over about 90 %, are accurate for all participants. In the lower data range, the Engineer 3 seems to display a bias using the photograph comparison method toward low values. On the other hand, Engineers 2 and 3 tend to be biased high for percent shear measurements in the 50 to 90 % shear range.

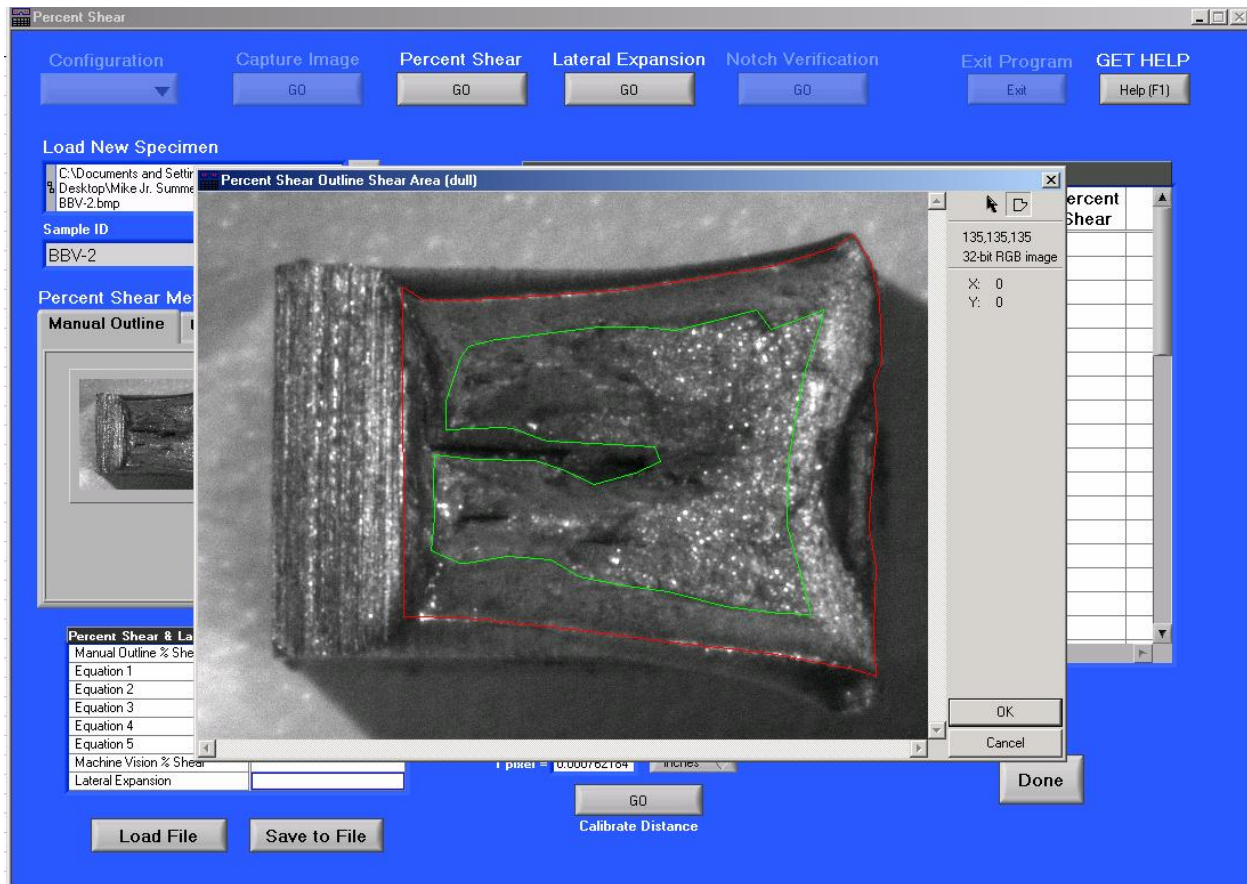
**Figure 9 Example Showing Outlines for the Brittle and Total Fracture Areas for a Test Specimen with a Large Crack Normal to the Primary Plane of Fracture.**

1. Calibration with a precision target was done before each day of measurements.
2. Each specimen was examined under a stereoscope and notes were taken on its fracture appearance.
3. As shown in the examples in Figures 9 and 10, a digital photograph of each specimen was taken at approximately 11X magnification, and the brittle area and outer area were outlined in the software.
4. The percent shear and areas were calculated and recorded in a spreadsheet and plotted (Figure 11).
5. A screen shot of the photographed specimen and outline was printed on a color printer for reference.

- Fourth, crack openings perpendicular to the fracture surface, even if shiny on the inner crack enclave region, were not included in the brittle area calculation. This is because the opening of the crack is due to plasticity and its area should not be in the brittle area calculation.

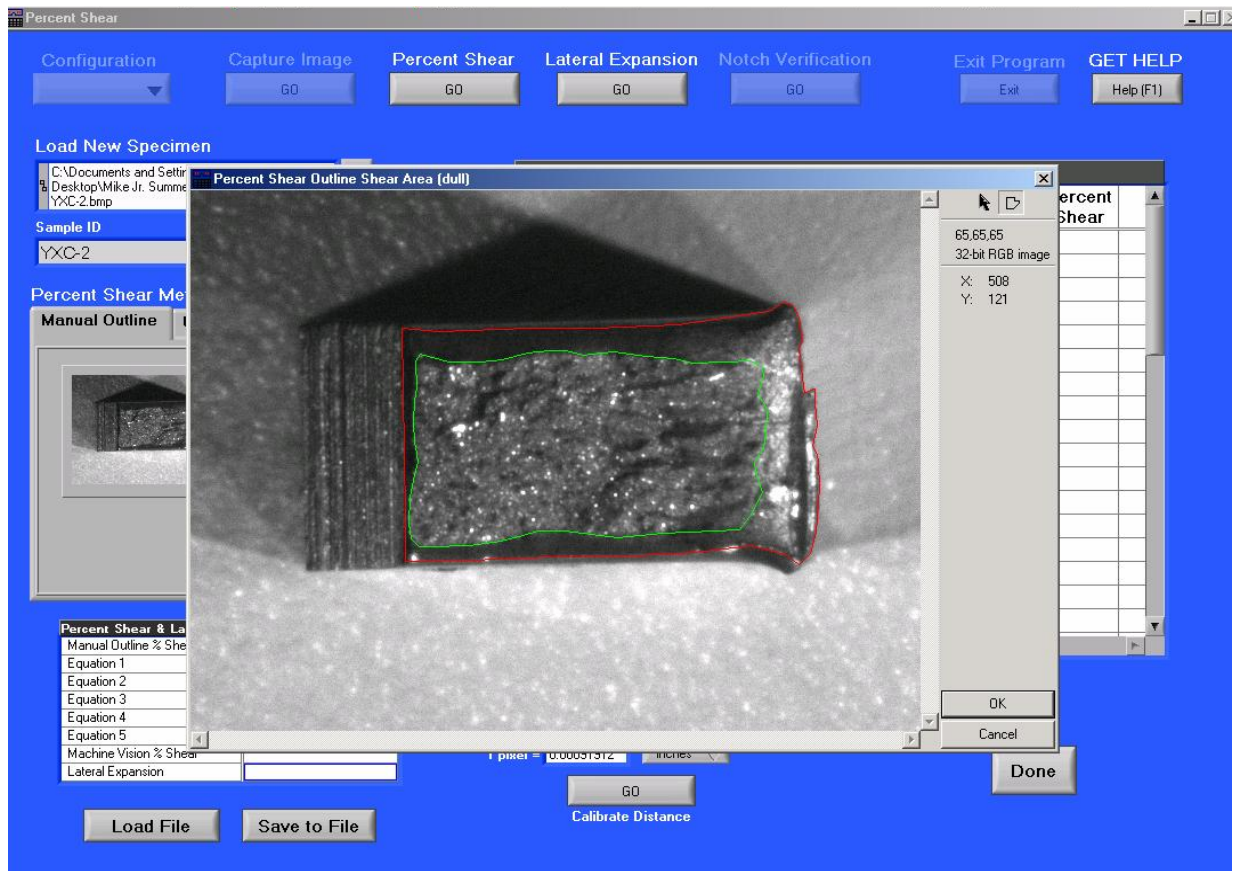
**Figure 10 Example Showing the Outlined Brittle and Total Fracture Areas, for a Sample Having a Flat Fast Fracture Region Lacking Clear Brittle Facets Throughout.**

- Third, all flat regions characteristic of fast fracture (especially on oxidized specimens where there were no decisive faceted, bright, shiny regions) were considered to be brittle areas.

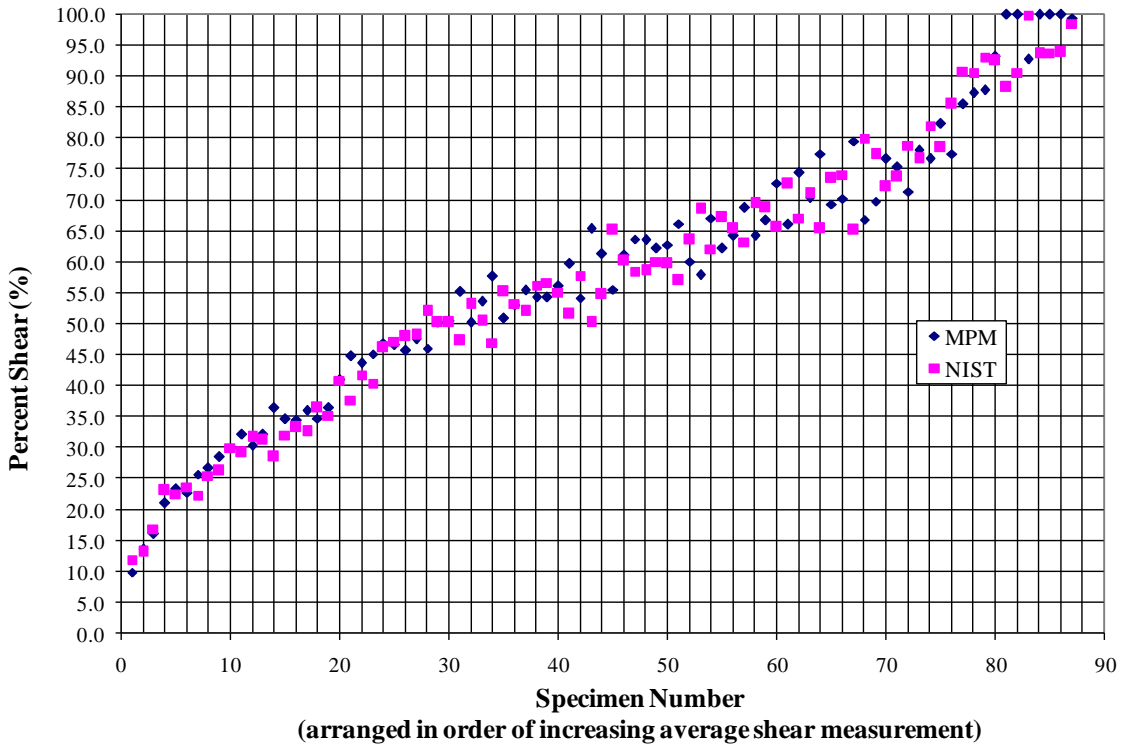
**MPM & NIST Data for Lake Erie Steel  
Round Robin**

**Figure 11 Comparison of Round Robin Percent Shear Data Obtained by NIST and MPM using Digital Imaging Technology.**

The digital analysis results are plotted in Figure 11. The data for the two independent imaging systems shows an average difference of 4.3 % SFA over the 87 specimens measured, and a maximum difference of 15.1 % SFA. It is interesting to note that the agreement is very close for SFA measurement up to about 50%, and it is again close at levels in excess of about 80 %. The transition region SFA data in the 55 % to 80 % range are more scattered due to mixed mode fracture regions and other effects such as cracking normal to the main crack front. In this region of SFA, differences between results were as large as 15 % SFA. These differences are due to the bias of the operator since the brittle area for some specimens was very difficult to see. Reference [9] reported results for a round robin using conventional Charpy specimens. In that study it was concluded that the level of agreement among participants was greatest when they were experienced, the results were close to the FATT, and simple, two-dimensional photographs were used for comparison. The Reference [9] work, as well as the current study, point to the importance of having well established rules for interpretation of the fracture surface features to minimize bias of the analyst.

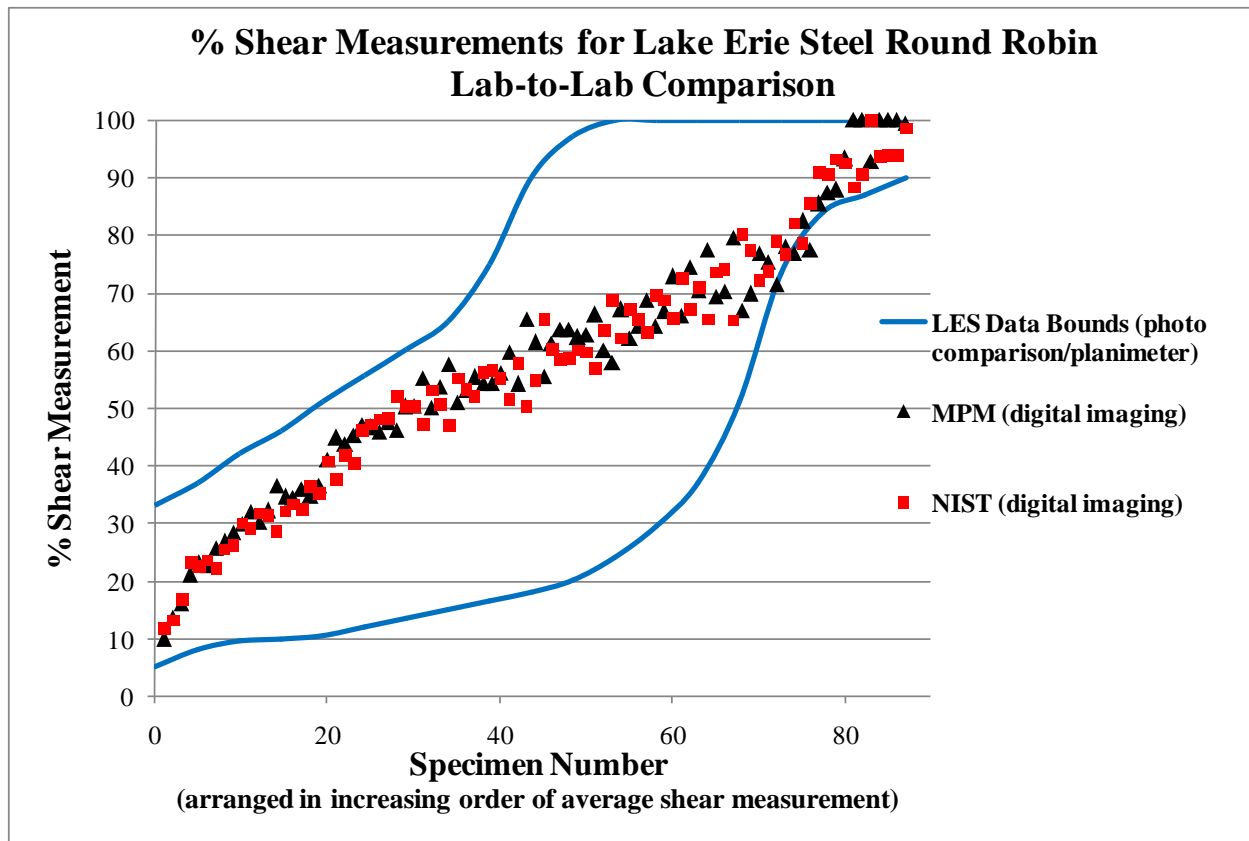
**Figure 12 Comparison of Data from the LES Round Robin with Results using Digital Analysis Technology from this Study. The Round Robin Data were Collected using Photograph Comparison and Planimeter Methods.**

As shown in Figure 12, data obtained via a combination of the photograph comparison method and the planimeter method resulted in a great deal of scatter. Differences as large as 70 % shear were reported, and the average maximum to minimum difference of the 5 participants for the 87 specimens was 41.9 % SFA. The subsized specimens are even more difficult to accurately analyze using photograph comparison, since only full-sized specimens are pictured in the current ASTM E23 standard. In addition, the specimens were hard to analyze due to the presence of oxidation, splits, and high levels of plastic deformation. Further discussion of the round robin results follows.

Figure 12 shows a much larger amount of scatter from lab-to-lab in the determination of percent shear by the five LES round robin participants. At this poor level of accuracy and low precision, further analysis of the round robin data is not meaningful other than to note that the scatter for the five labs is somewhat lower at the low and high SFA levels.

As discussed earlier, two sources for the scatter have been identified: operator bias and method error. The error caused by an operator's bias is simply an operator's inability to see and/or to physically interpret what is seen as either brittle area or ductile area. Method error, on the other hand, varies significantly according to the method used. To date, the two methods that are most commonly used are the photograph comparison method (method 2 listed in the ASTM E 23 standard) and the digital imaging method (method 5 listed in the E 23 standard). Between these, the photograph comparison method is the most widely used in the steel industry. However, this method, according to the E 23 standard, is the second least accurate method in measuring percent shear. Therefore, given the difficulty in comparing subsize photographs to full size, and the highly deformed fracture surfaces, it would be relatively easy to be three or four photographs away from the correct photograph, resulting in error bands on the order of 40 to 70% shear, which is observed in Figure 12. The digital imaging method, as shown in the earlier
